Project Profile Gas Holder

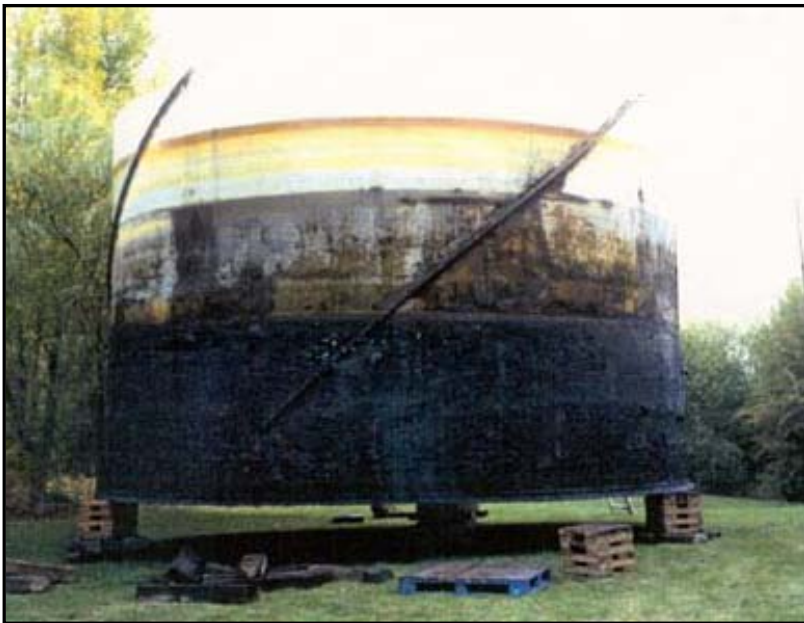
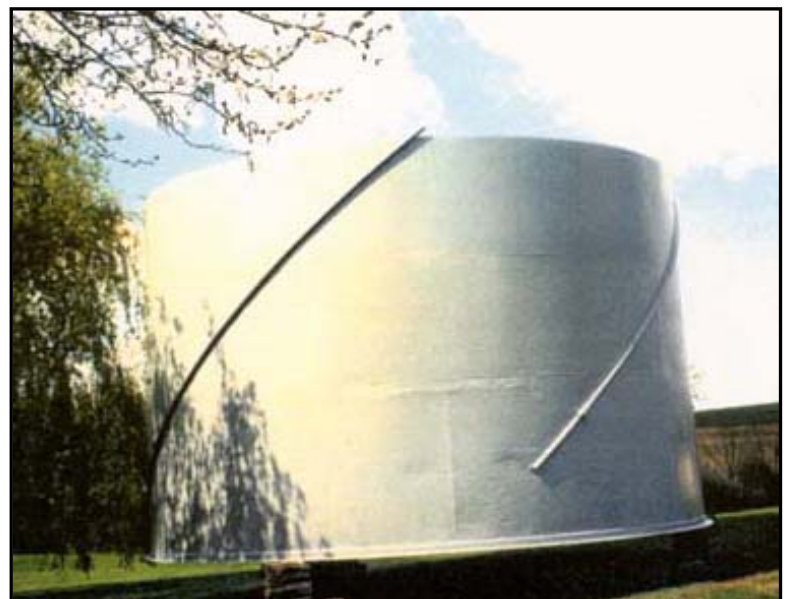
The gas holder had been allowed to deteriorate into a very bad condition. There was extensive rusting and after grit blasting, 50-60 holes had appeared in the lower third section.

After the entire gas holder had been grit blasted, the inside was coated with one coat of Uni-Tech MC Primer and two coats of Chemi-Tech CR reinforced system.

On the outside, holes were filled with Metal-Tech EG and mesh, then the entire surface was coated with one coat of Corro-Tech GP and two coats of Poly-Nox.
