Profile: Furnace Exhaust Gas Ventilator Refurbishment

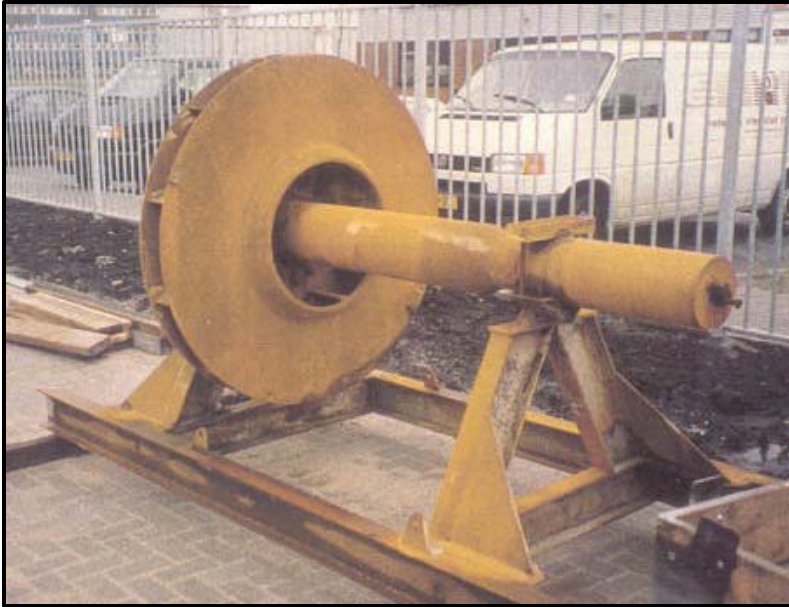
The housing, impeller and castings of this furnace exhaust gas ventilator had been marked for refurbishment.

The client required a high temperature resistant coating.

The internal components were abrasive blast cleaned to ensure all loose abrasive dust and debris were cleaned away and then **Thortex Cerami-Tech HTX** was applied.

Thortex Cerami-Tech HTX is a high-performance, fluid-grade engineering resurfacing compound developed for high temperature immersion conditions and is ideal for resurfacing pumps, impellers, valves, tube sheets, water boxes and heat exchangers.
