## Project: Primary Sludge Pump

### The Problem

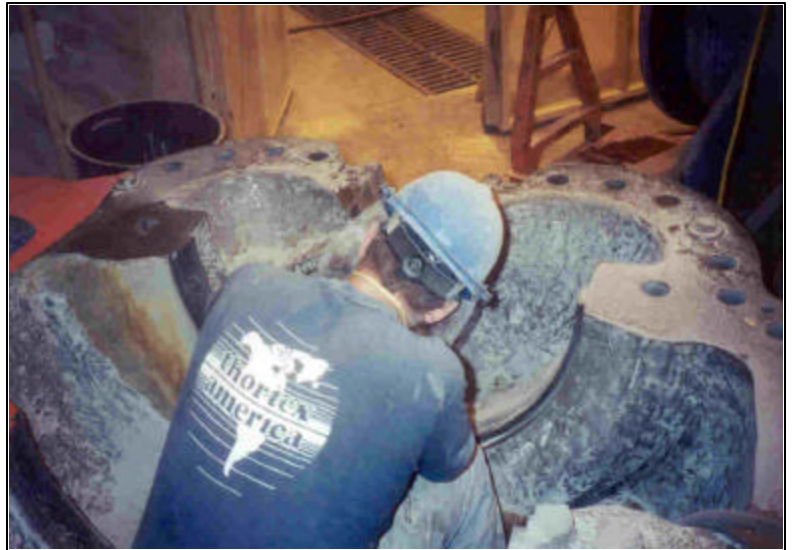
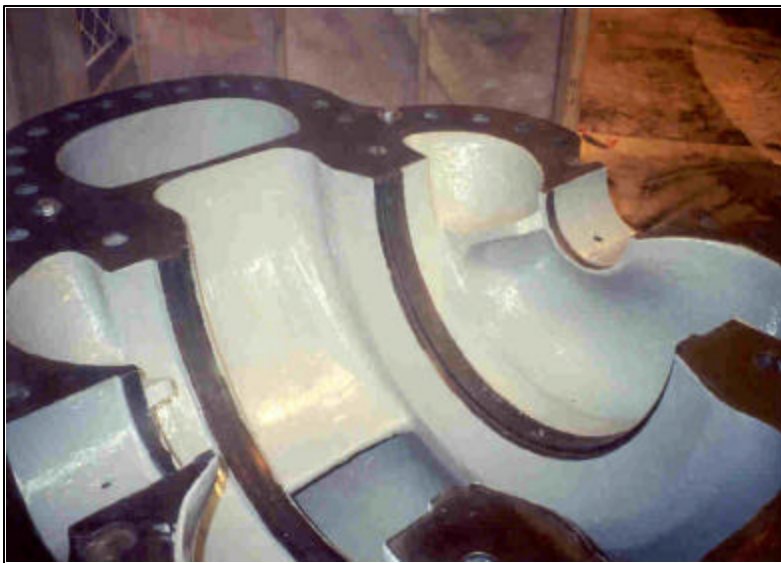
This WWTP's primary sludge pump wasn't working to capacity because of years of wear and erosion.

RPT abrasive blasted the pump housings and then rebuilt the pump to its original tolerances using **Thortex Cerami-Tech EG** and two top coats of **Thortex Cerami-Tech FG**.
