## Project Profile

# Shower Block Floor Refurbishment

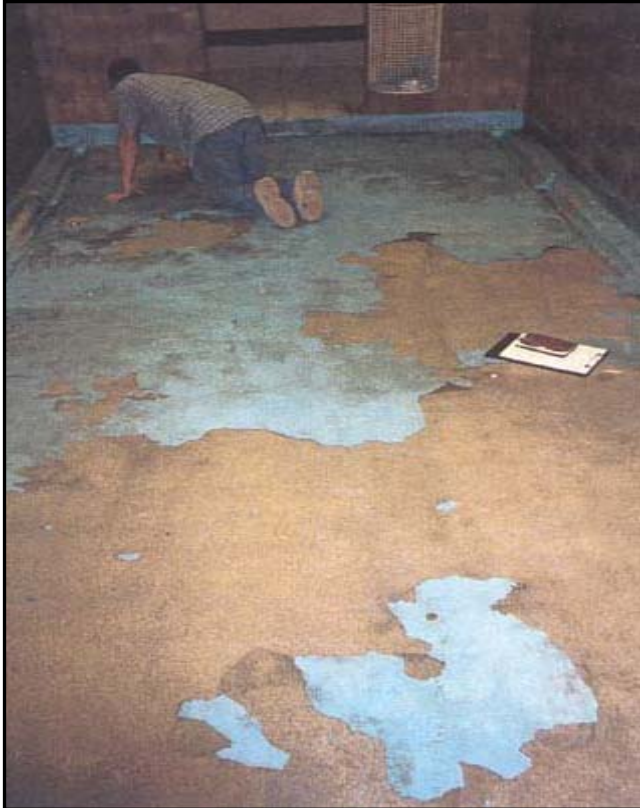
The floor was in poor condition and was becoming unhygienic. The client wanted a high performance coating system which would provide a high performance solution to the problem.

The entire floor was primed with Floor-Tech SP Primer prior to the application of two coats of Floor-Tech WB, which incorporated Floor-Tech WB Aggregate to provide the required slip-deterrent finish.
