## Project: 54" Pipe Wrap

### The Problem

This WWTP's main in flow pipe – carrying 350 million GPD - had ruptured in several small areas.

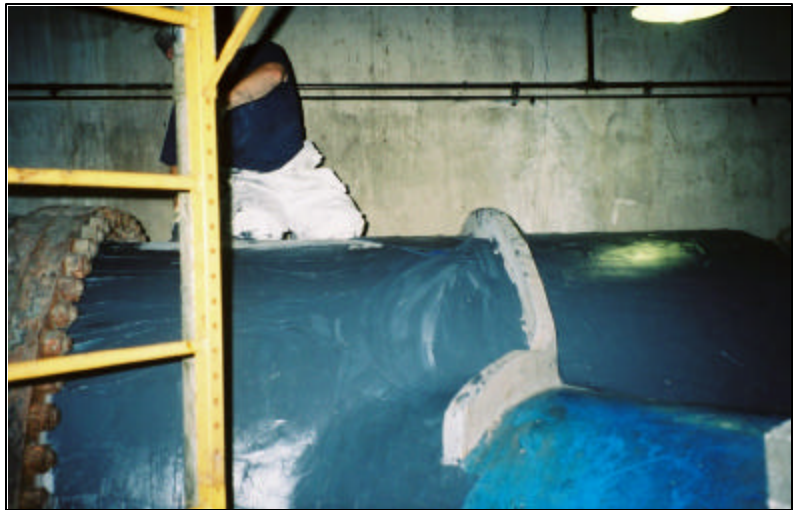
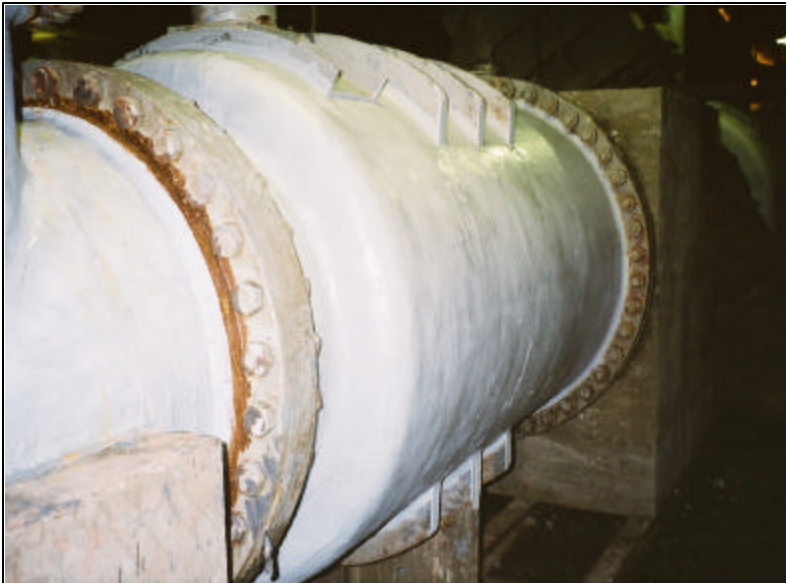
RPT and Thortex were called in to affix the repairs during a narrow shutdown window.

RPT applied **Thortex Cerami-Flex EG** at 120 mils over the prepared pipe surfaces. Nylon mesh was imbedded in the wet **Thortex Cerami-Flex EG**. A second coat of **Thortex Cerami-Flex EG** was applied at 60 mils over the meshed surfaces.

A final topcoat of **Thortex Cerami-Flex FG** applied at 40 mils. The finished system was at 240+ mils.
