Profile: Concrete Repair & Protection

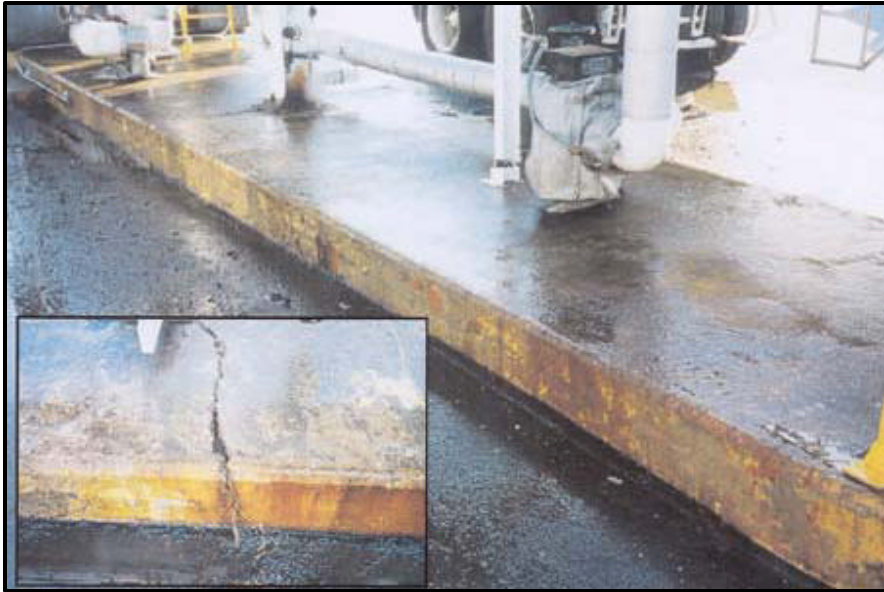
The project was to completely repair the concrete and coat the surface to provide protection against chemical attack.

The damaged concrete was reinstated using **Thortex Floor-Tech RS**. The entire concrete surface was coated with **Thortex Floor-Tech SP Primer**, the metal areas with **Thortex Uni-Tech MC Primer**, over which **Thortex Chemi-Tech CR** was applied.
