Project: Containment Area Refurbishment

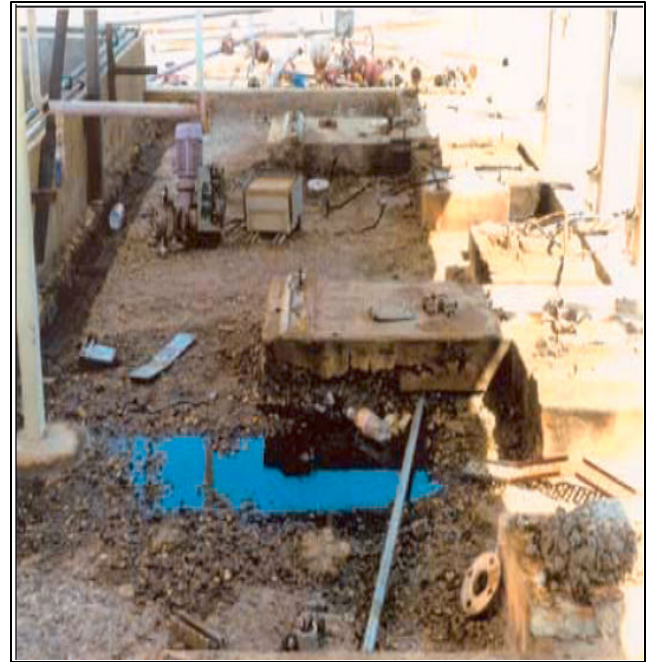
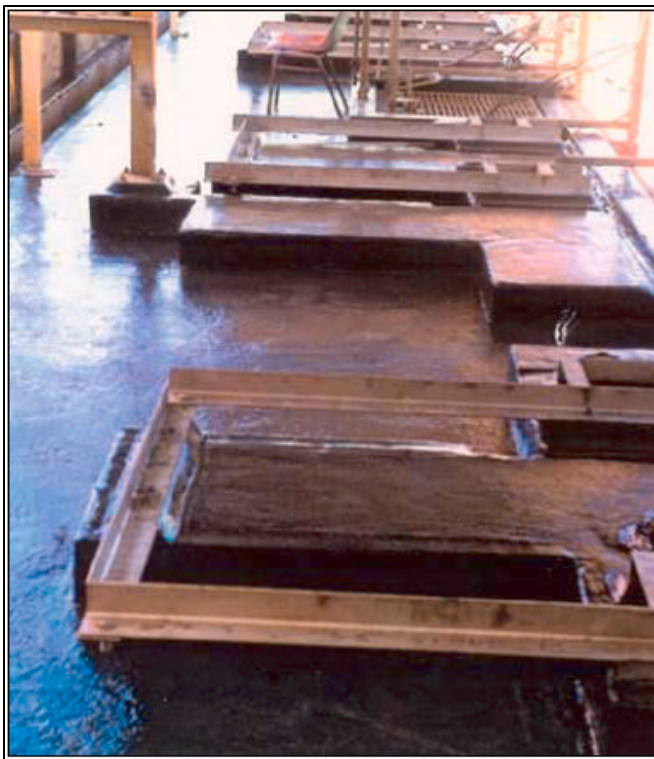
Severe erosion of the concrete plinths and containment area at a power station was caused by a sulphuric acid spillage.

The concrete was rebuilt to its original specifications with **Thortex Grano-Tech** and **Thortex Floor-Tech RS**.

RPT then applied 2 Coats of **Thortex Chemi-Tech UC** to the entire area.
