## Project: Cooling Tower Supports

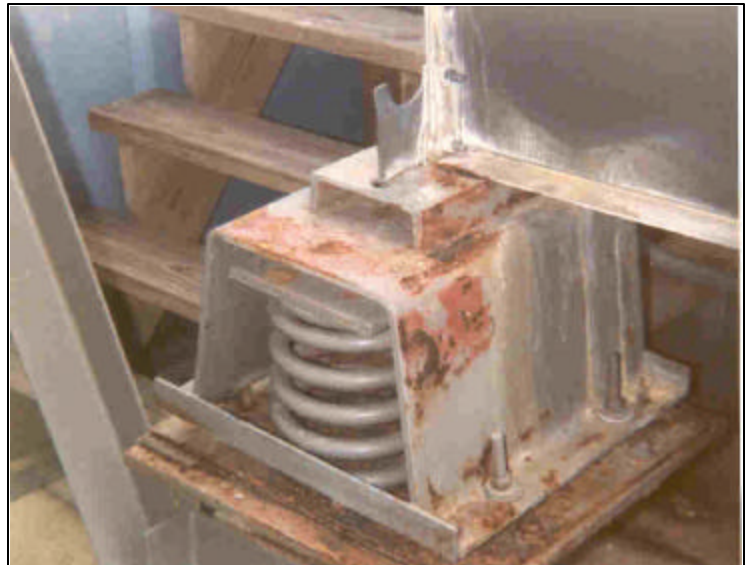
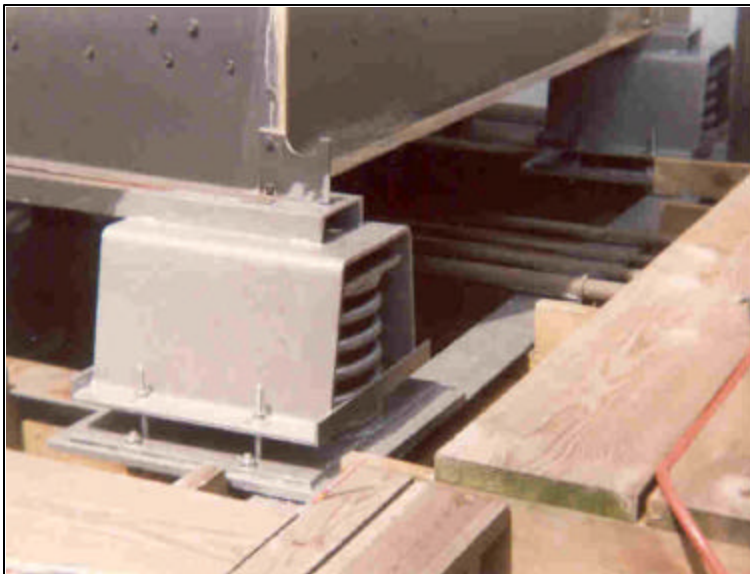
These cooling tower supports were corroding from environmental effects as well as salts and chlorides.

RPT pressure washed the supports and coated them with two coats of **Thortex Corro-Tech GP** followed by a top coat of **Thortex Poly-Nox**.
