## Project: Water Treatment Plant Dam

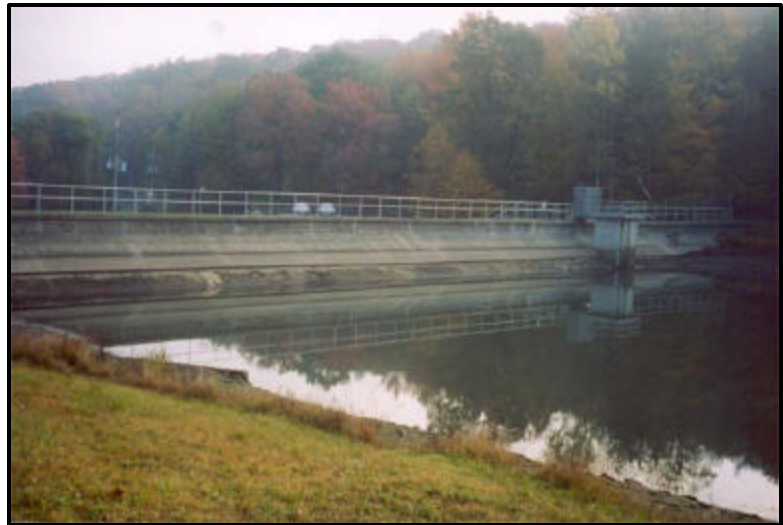
This water treatment plant had water infiltration through their dam and subsequent erosion of the support fill.

This authority chose RPT and Thortex to replace over 1100 linear feet of joint with **Thortex Flexi-Tech 80 EG**.

**Thortex Flexi-Tech 80 EG** is a solvent-free, paste-grade elastomer that is applied by trowel or putty knife and possess outstanding mechanical strength when cured.
