Project: Waste to Energy Plant

The Problem

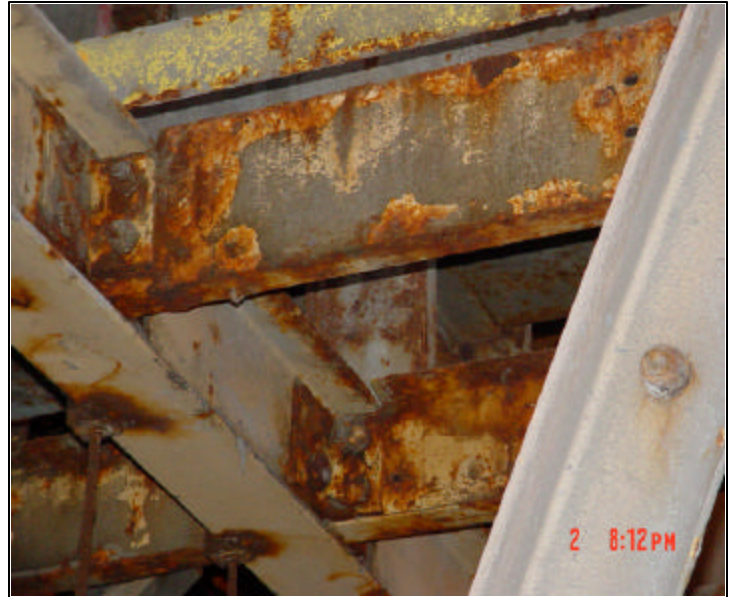
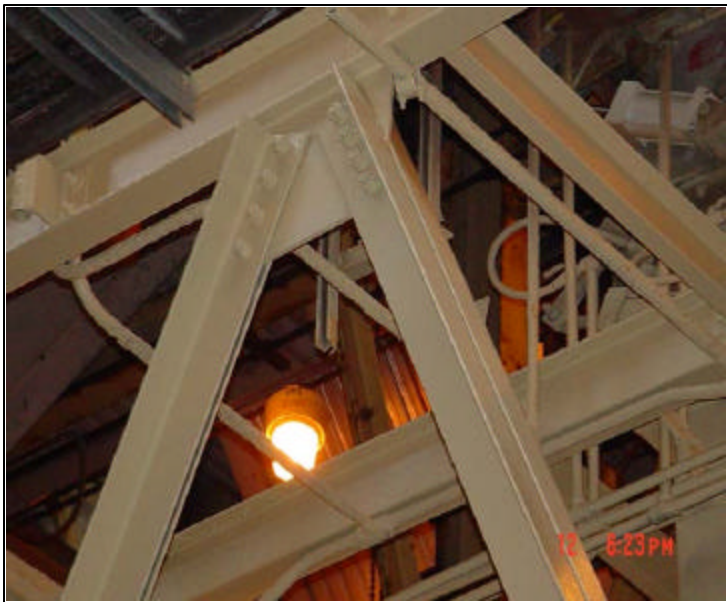
The structural steel in this waste to energy plant showed severe damage from corrosion.

The steel was sweep blasted and pressure washed to remove all of the flaking and peeling coating and packed rust. Two coats of **Thortex Corro-Tech GP** were applied to prevent future corrosion and then a final coat of **Thortex Poly-Nox** - in a custom color matched to the client's specifications - was applied.
